## MEDIA RELEASE

### NELSON TENNIS COURTS TAKE A “HIT”

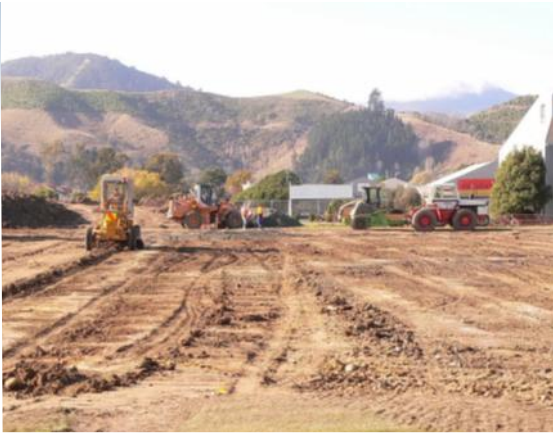
IR7

An innovative approach to improving ground conditions on uncontrolled fill using a Broons BH-1300 “Square” Impact Roller served up fast and cost-effective compaction results on a Council’s tennis courts. The eight grass courts at the Paru Paru road Tennis Centre in Nelson, on New Zealand’s South Island, had been built over an old uncontrolled waste tip which had previously been an old river bed. As is so often the case on such sites, the surface suffered differential settlement over the years. Reconstruction was called for and the job was secured by Fulton Hogan.

Ground improving using the Broons BH-1300 Impact Roller unit, owned and operated by Taylors Contracting of Brightwater, with advice provided by Broons personnel from Australia, was chosen due to its ability to produce fast, cost-effective, deep in-situ soil compaction.

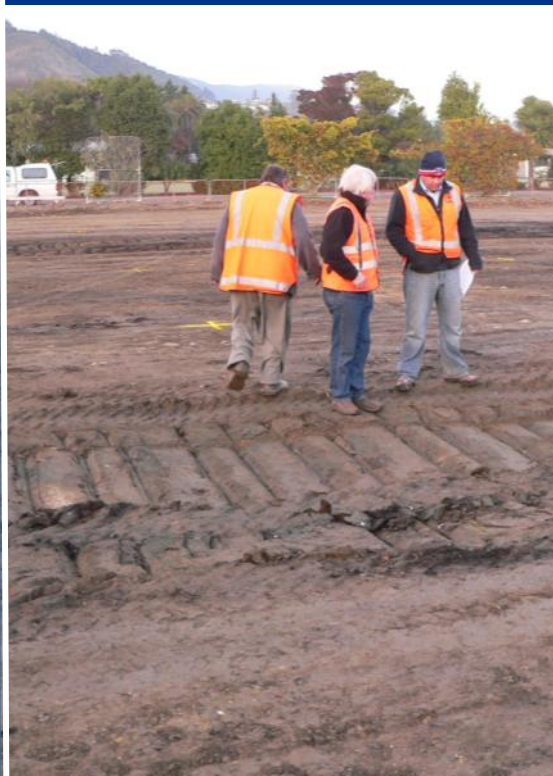
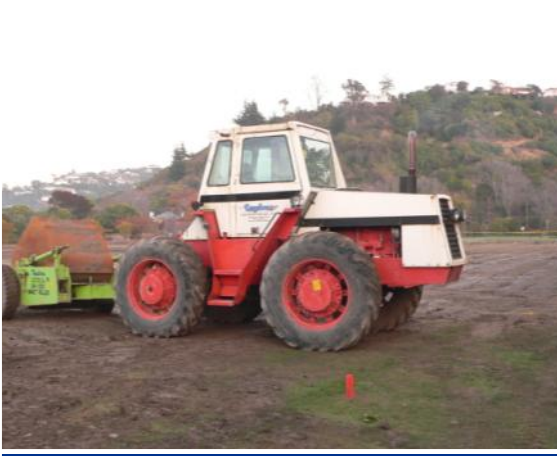
Settlement monitoring was carried out on a 6m grid across the whole treatment area. After each set of six passes of the Impact Roller the site was lightly “brushed” with a grader to even out the surface, and new levels were taken from which average settlements were calculated. This process was repeated until Graham Walker, the engineer supervising the work on behalf of the Council, was satisfied that “effective refusal” has been achieved, which is the point at which additional passes of the Impact Roller are unlikely to achieve any further significant settlement.
